EARTH TESTING CASE STUDY

Safearth CS3 Test Prevents HV Outage

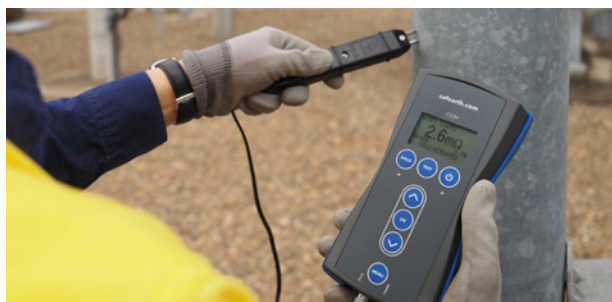
In an earth grid integrity test in Wisconsin, USA during December 2015, the CS3 identified a set of 3 line voltage transformers which had their main grid bond severely deteriorated or damaged below grade. The VT's were found to be bonded via the screen of the control wiring only. Left unrepaired, this situation may have led to spurious trips on the line, significant equipment damage in the event of a fault or potentially hazardous conditions for workers on the control wiring.

The use of a comparably low 1A test current in the CS3 enabled this serious defect to be identified accurately without causing any negative impacts, whereas a high current test (10A or greater) may have caused damage to the control wiring, likely resulting in an outage.
